NASA CR-159798
IITRI-M6003-53

THERMAL FATIGUE AND OXIDATION DATA
FOR DIRECTIONALLY SOLIDIFIED
MAR-M 246 TURBINE BLADES

V. L. Hill and V. E. Humphreys
Materials Technology Division

IIT RESEARCH INSTITUTE
10 West 35 Street
Chicago, Illinois 60616

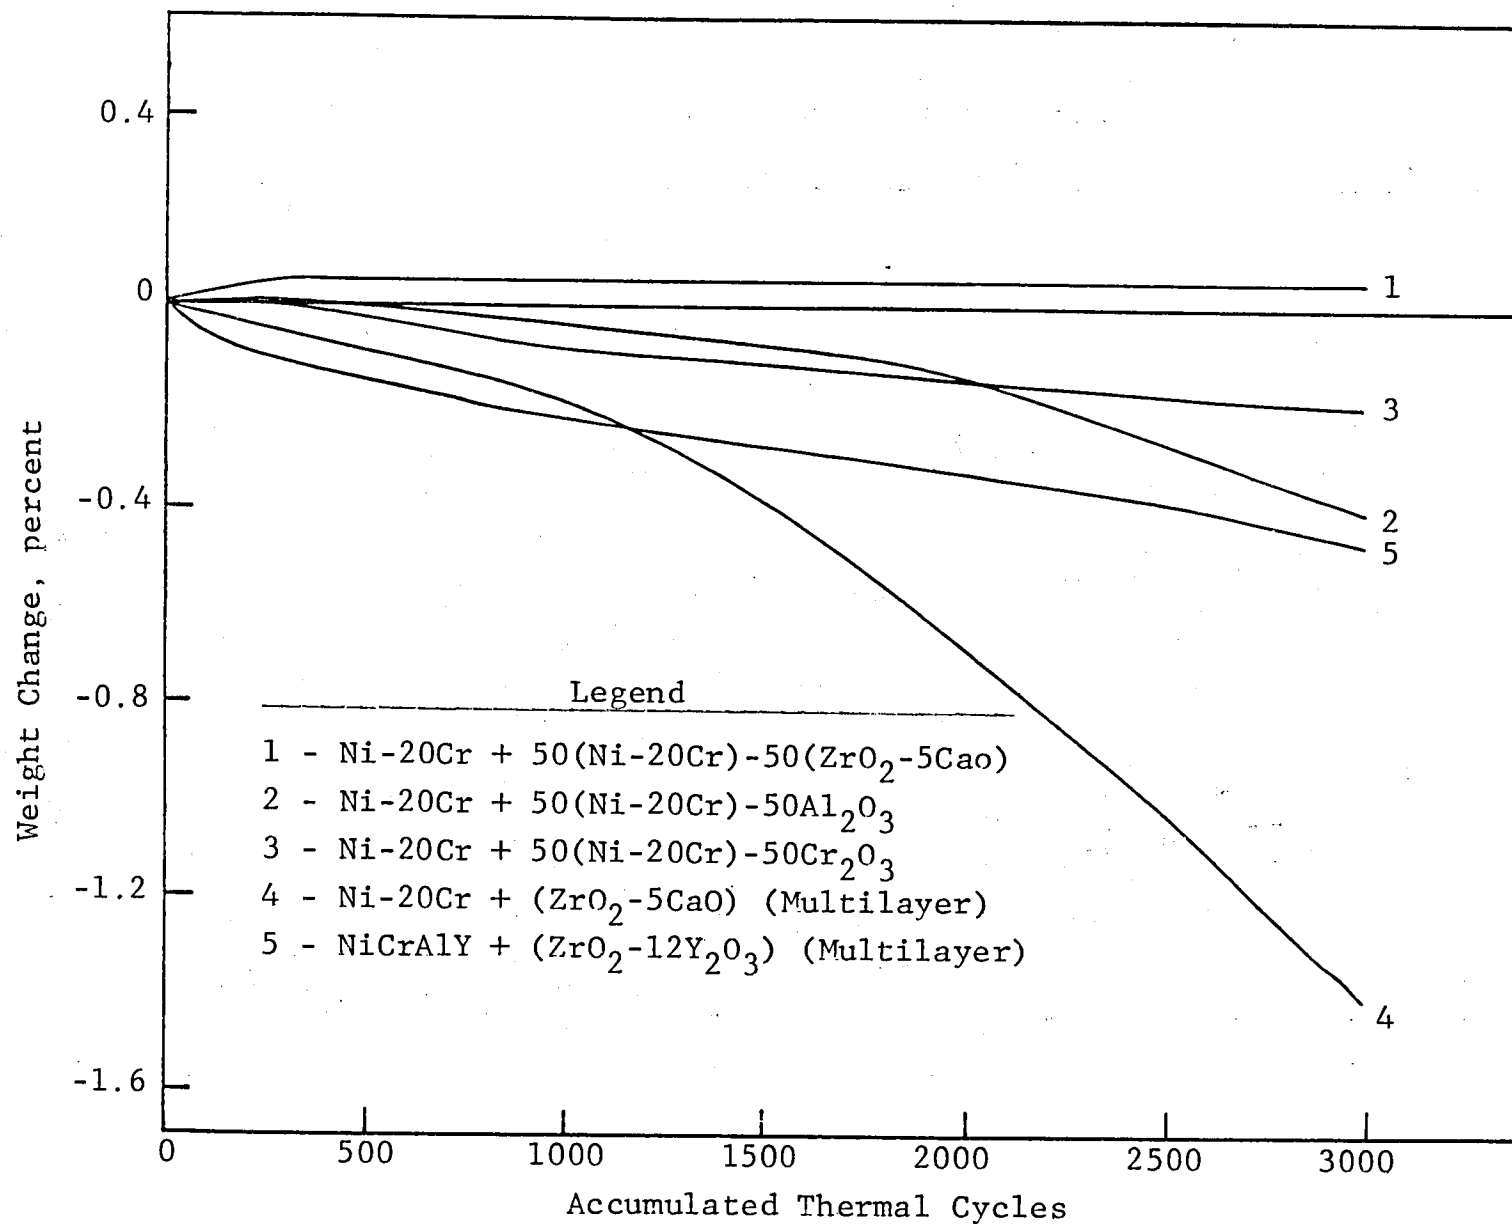
Figure 4
Percent Weight Change versus Accumulated Thermal Cycles
for Plasma Spray Coated Blades 1-5

Weight change data plotted versus accumulated cycles in Figs. 4 and 5 for coated blades is that of the individual blades. Data for uncoated blades presented in Fig. 6 are the averages of the three blades of each general category. Lowest weight loss occurred for the etched DS blades 21 to 24, with the other three groups of uncoated MAR-M 246 indicating similar weight change behavior. No difference in oxidation of directionally solidified and single crystal material was apparent.

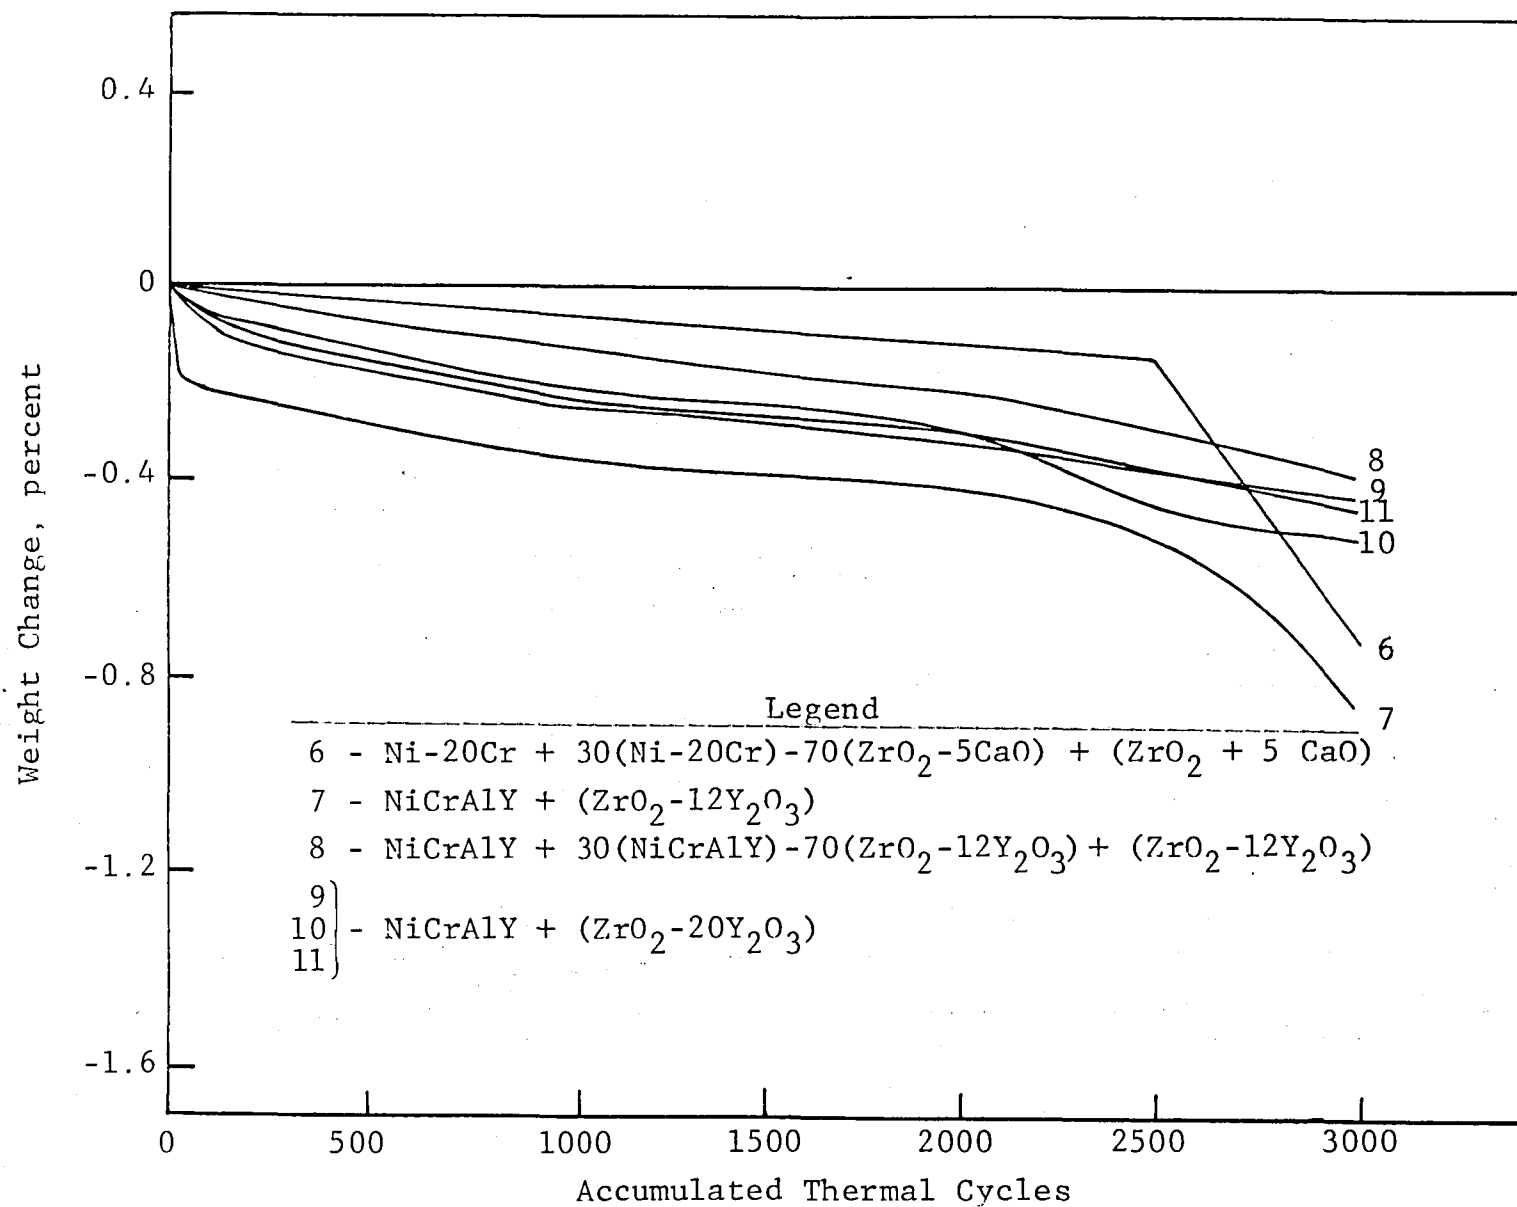
Figure 5

Percent Weight Change versus Accumulated Thermal Cycles
for Plasma Spray Coated Blades 6-11
